# CREAMER ENVIRONMENTAL, INC.

<b>DATE: 3/8/16</b>	<b>JOB NO.: 16-0463</b>
<b>ATTENTION: Nicholas Steenhaut</b>	
<b>RE: Metal Bank NPL Site</b>

COPIES	DATE	PAGES	DESCRIPTION
1	3/8/2016	2	Submittal #7.1 Waler Repair Sequence and Procedures

## Metal Bank NPL Site Philadelphia, PA Waler Repair Sequence and Procedures

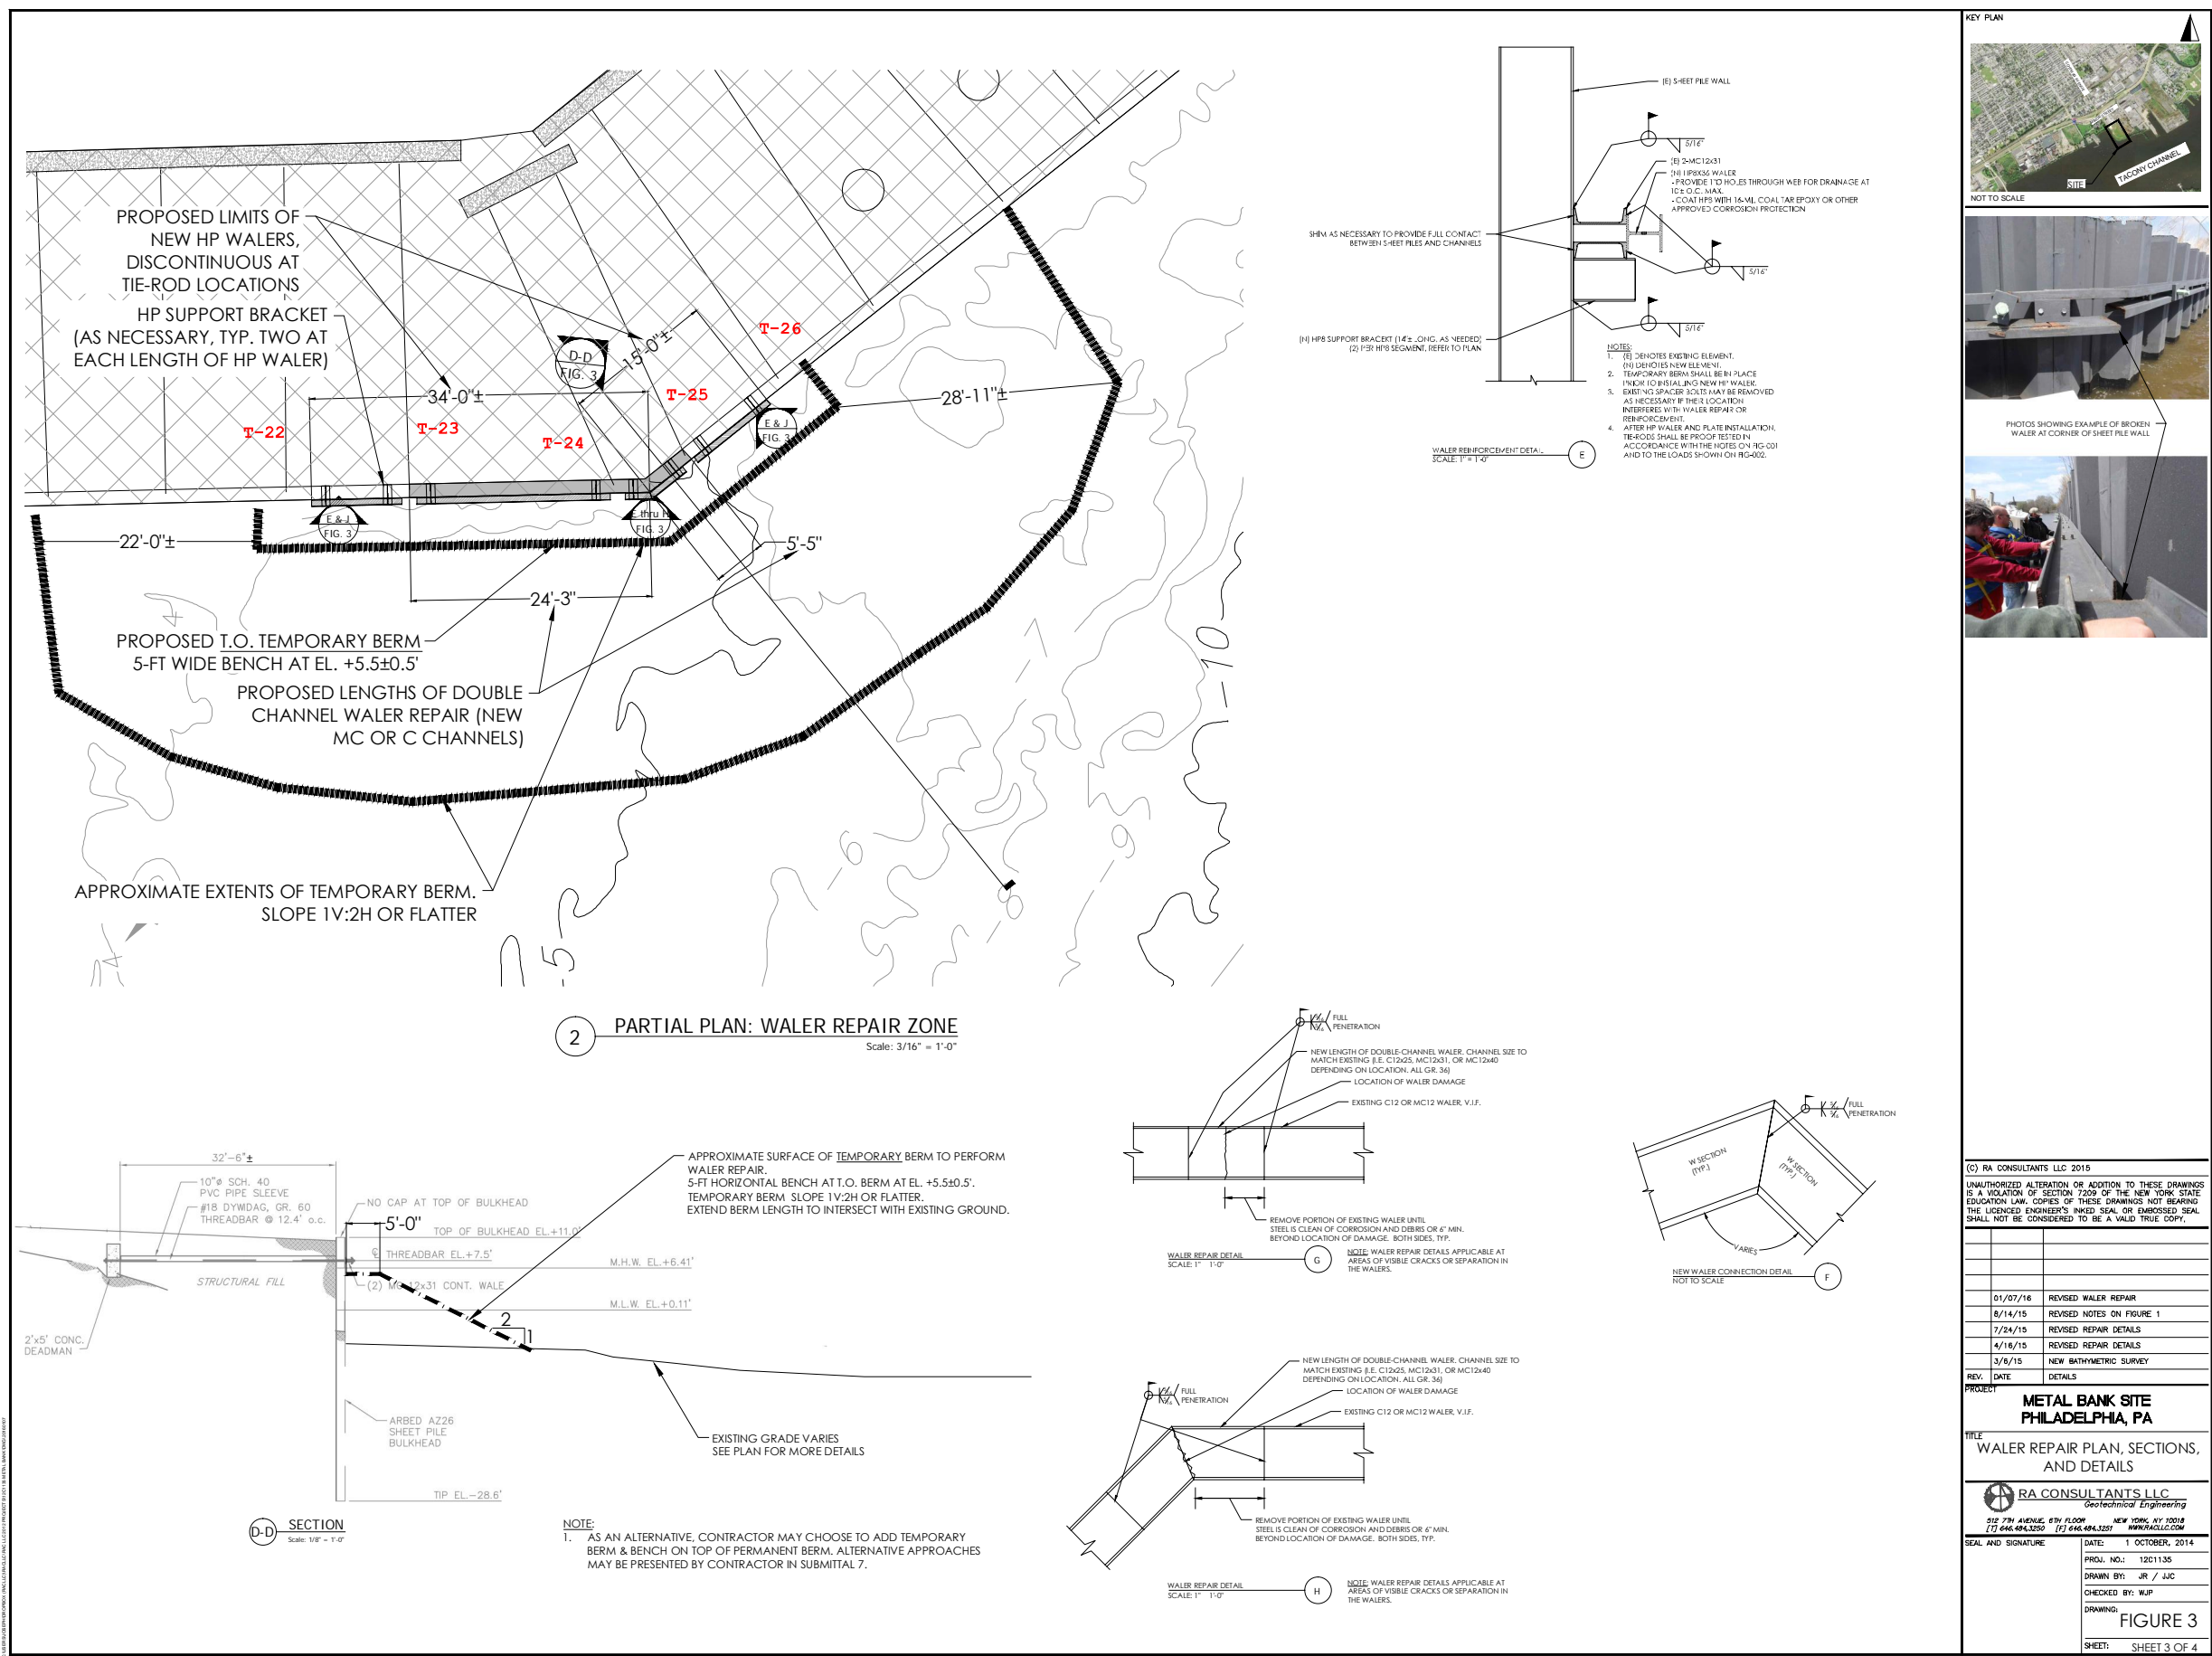
## WALER REPAIR

Creamer Environmental, Inc. (CEI) will procure the coated steel materials following the approval of material sources and field verification of existing materials. CEI will access the waler repair from the 5' wide rip rap platform installed within Zone 2. The waler repair requires the removal of the existing double channel waler to the limits shown on the plans and the installation of a new pair of channels. The new channels will be welded into place as shown on the details, using full penetration welds on the ends and at the corner to connect the double channel as a continuous waler. These walers will be held in place with the existing plates on the tie-rods as well as the new HP support brackets to be installed as per plan.

The support brackets are installed to help hold the added weight of the channel system at the corner. Four segments of HP8 waler will be installed in front of the double channel waler where it has been repaired as well as with a segment north and south of the repair section. The new HP8 waler will be interrupted at each of the tie-rod locations, T-23 through T-25, allowing 1' of clearance on either side of the tie-rod itself as per the attached figure. In order to allow for the waler to drain, 1" diameter holes will be installed 10' on center through the web of the waler.

The walers and beams to be delivered to the site will be coated with a minimum of 16 mil epoxy to maintain the corrosion protection. All locations where welding is to occur will be cleaned such that a proper weld can be performed. The welding will damage the coating in the area of the weld, and the exposed surfaces will need to be recoated. The exposed areas where the coating has been removed or damaged will be cleaned and coated using field touch up kits that are compatible with the coating on the existing sheeting.
